State of California  
The Resources Agency  
Department of Water Resources  
Division of Environmental Services  
Site Assessment Section  
1725 23<sup>rd</sup> Street, Suite 220  
Sacramento, California 95816

## PHASE II ENVIRONMENTAL SITE ASSESSMENT

### IN-DELTA STORAGE PROJECT CONTRA COSTA & SAN JOAQUIN COUNTIES, CALIFORNIA MAY 2003

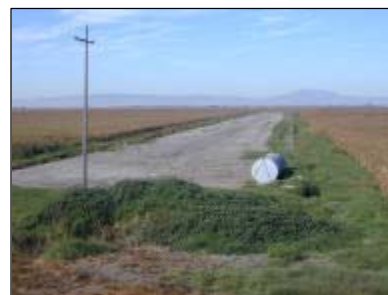
Photo 1

The runway is a roughly paved strip situated one and one-half miles north of the Bacon Island Bridge, near the east levee road (Photo 1). The runway is situated in an east-west direction. Stained soil was observed in the area south of an aboveground fuel tank.

One sample was collected at 0.5 feet below ground surface towards the eastern end of the runway approximately 30 feet south of the fuel tank. Sample results are shown in Table 1.

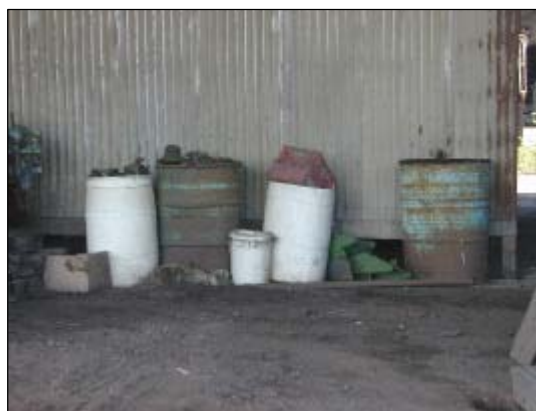
Photo 2

A farm operations headquarters is located approximately one mile southwest of the northeast corner of the island. Four unlabeled 55-gallon drums were observed in the northernmost storage shed (Photo 2). Stained soil was observed in the vicinity of the drums. Samples were collected south of the drums, on the opposite side of the wall visible in Photo 2. The wall does not touch the ground, therefore any spillage or leakage from the drums would also be detected there. Sample results are shown in Table 2.

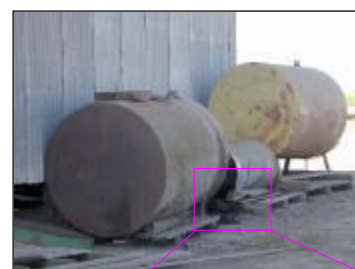
Photo 3

Two aboveground storage tanks and one 55-gallon drum were identified in the Phase I ESA report. The tanks and drum are located on the north side of the northernmost storage shed at the north farm headquarters (Photos 3 and 4). Stained soil was observed in their vicinity. Surface and depth samples were collected between the containers, where the worse stain was

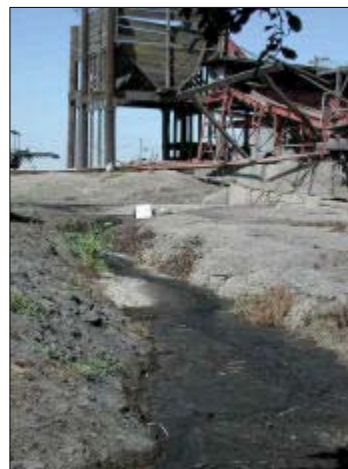
Photo 5

An equipment wash-down area was identified during the Phase I ESA. The wash-down area is located on the south side of the packing shed at the north farm headquarters. Wet soil was observed at this location. However, it is often difficult to distinguish between soil that is wet with water and soil stained with chemicals. Therefore, samples were collected at this location (Photo 5). Authoritative surface and depth samples were collected where the majority of the wash-down rinseate seem to collect. Sample results are shown in Table 4.

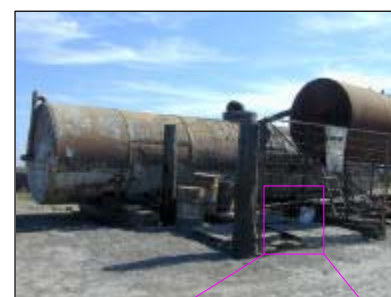
Photo 6

The Phase I ESA identified two aboveground storage tanks approximately one-eighth mile southeast of the packing shed. A fenced enclosure in this area also contained four 55-gallon drums and one 5-gallon container. Stained soil was observed under the 55-gallon drums as well as in the vicinity of the 750-gallon tank (Photos 6-7). SAS staff noted that upon visiting this location to collect samples, that the drums, fence, and smaller tank were absent. One surface sample was collected. Sample results are shown in Table 5.

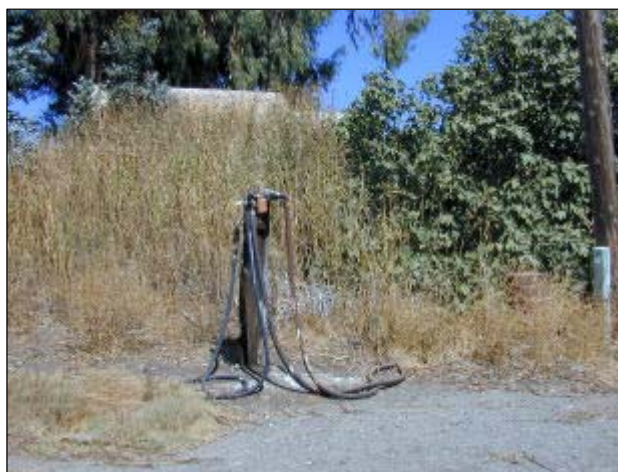
Photo 8

The Phase I ESA identified two aboveground storage tanks along the northwest levee road. The tanks are apparently supply fuel for the valve downhill from it (Photo 8). Stained soil was observed in the area surrounding the pump. One surface sample and one depth sample was collected. Sample results are shown in Table 6.

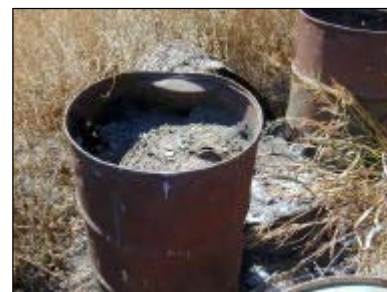
Photo 9

The Phase I ESA identified ten 55-gallon drums and approximately 20 tires at the northeast end of the shed. None of the drums were labeled. No signs of leakage or spillage were observed in the area surrounding the drums. One open drum appeared to be used to burn trash. Within the debris in the drum, burnt oil filters were observed (Photo 9). One surface sample and one depth sample were collected. Sample results are

The soil samples collected near the burn drum revealed high levels of oil and grease, especially in the surface sample (highlighted in red) that may require remediation. The subsurface samples also detected the a trace amount of p,p'-DDE, a pesticide. No other samples detected the presence of an element or compound at a level of concern, nor do they exceed the regulatory threshold value (if available).

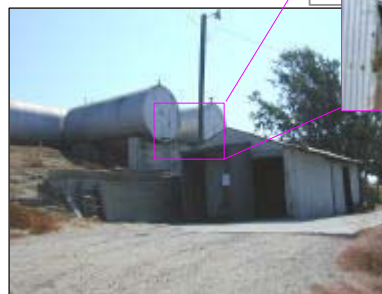
Photo 10

The Phase I ESA identified stained soil under two aboveground fuel tanks at the farm headquarters (Photos 10-11). Samples were collected from the stained area along the south side of the tanks. Sample results are shown in Table 8.

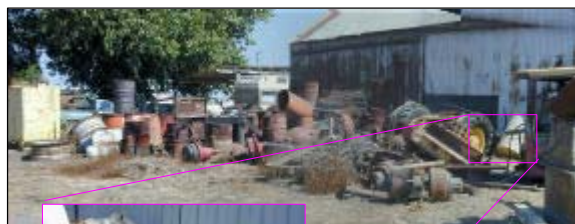
Photo 12

The Phase I ESA identified approximately twenty-five 55-gallon drums and farm machinery parts west of the equipment storage shed. Some of the drums were observed to be empty. However, others were sealed and unlabeled. Stained soil was observed in the area under and around the drums and equipment (Photos 12-13).

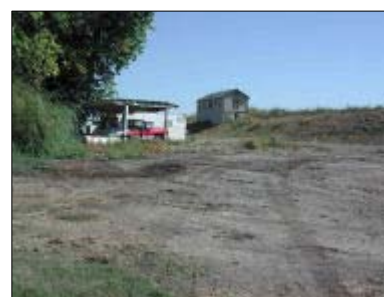
Upon visiting this location for collection of soil samples, SAS staff noted that all trash, drums, and equipment, had been removed. SAS staff also noted the absence of the storage shed. Note that Photo 14 was taken from the same location and direction as Photo 12. One surface sample was collected where SAS staff could best determine the location of the drums. Sample results are shown in Table 9.

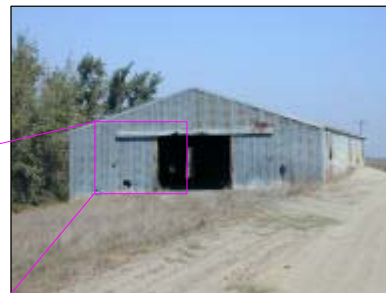
Photo 15

The Phase I ESA identified a barn situated along the east side of the tract (Photo 15). Within the barn, it was noted that the concrete foundation was stained along the west side. Further observation noted that the staining ran down the outside of the foundation and into the soil

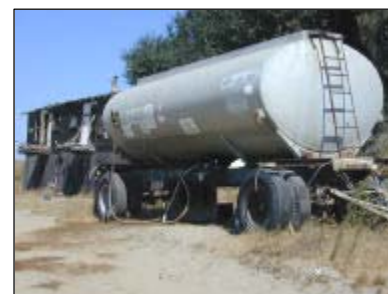
Photo 17

The Phase I ESA identified a farm equipment staging area approximately one-half mile south of the north tip of the island. Numerous tractors, trucks, and implements were observed at this location. A 10,000 gallon diesel fuel trailer was observed here (Photo 17). The soil under the trailer was stained.

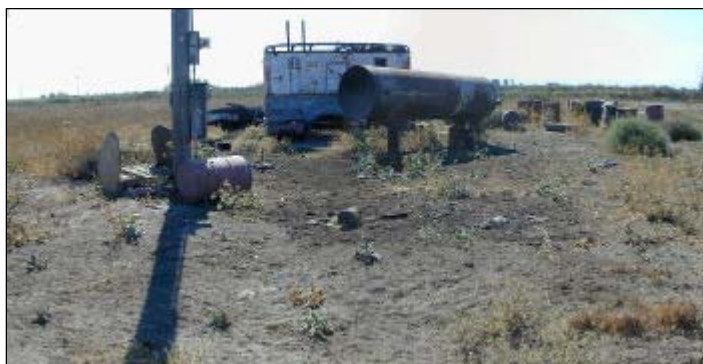
Photo 19

The Phase I ESA identified a waste oil storage area situated one and one-half miles north of the south levee entrance gate (Photo 19). Observations at this location included one 500-gallon aboveground storage tank, 28 55-gallon drums, approximately 30 used engine oil filters, and two tractor batteries. Wide-spread soil staining was observed in the area

surrounding the drums and 500-gallon tank. Soil samples were collected in four locations: eight feet north of the telephone pole, near the palette of batteries, under the storage tank, and approximately 20 feet west of the tank among the 55-gallon drums. Sample results are shown in Tables 13-15.

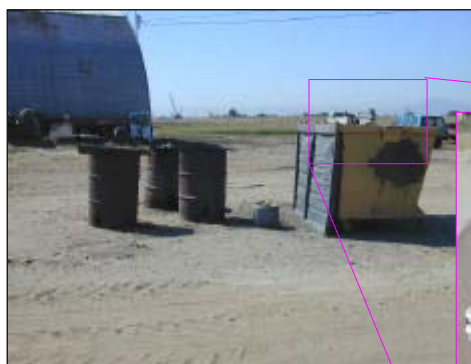
Photo 20

The Phase I ESA identified three 55-gallon drums north of the maintenance shed. These drums were apparently used for burning trash. A dumpster was observed by the drums that apparently was where ash from the drums was placed. Among the waste in the dumpster, burned heavy equipment oil filters were observed (Photos 20-21). Soil samples were collected in the area between the drums and trash bin. Sample results are shown in Table 17.

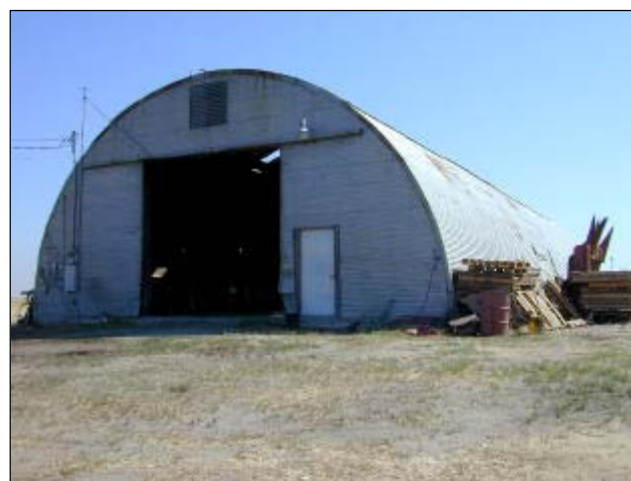
Photo 22

The Phase I ESA identified stained soil on the west side of the equipment maintenance building (Photo 22). Samples were collected approximately 20 feet west of the northwest corner of the building. Sample results are shown in Table 18.

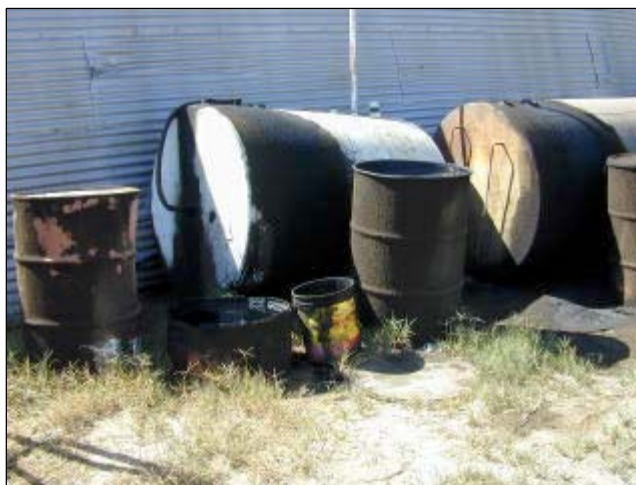
Photo 23

The Phase I ESA identified stained soil on the north side of the equipment maintenance building by open 55-gallon drums and aboveground storage tanks (Photo 23). Samples were collected on the east side of the drums and tanks. Sample results are shown in Table 19.

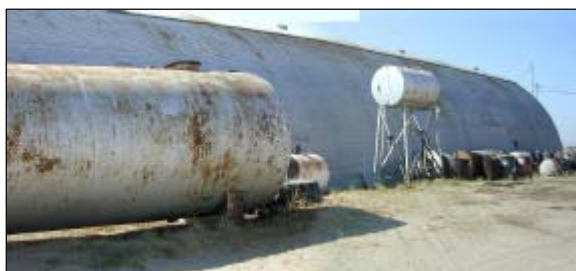
Photo 25

The Phase I ESA identified stained soil on the north side of the equipment maintenance building under an aboveground diesel fuel tank (Photo 24). Additional staining was identified in the area surrounding a fuel tank in the same location (Photo 25). Soil samples were collected under the tank. Sample results are shown in Table 20.

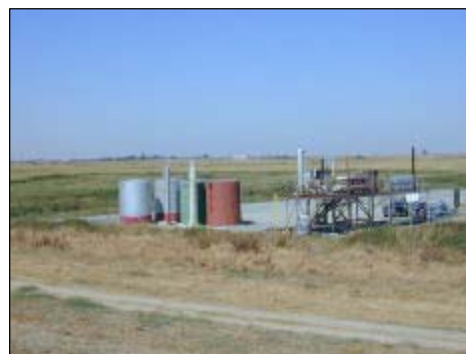
Photo 26

The Phase I ESA identified a gas well facility situated along the south levee road approximately two miles west of the pumping station (Photo 26). Stained soil was observed under the elevated pump structure. Samples were collected at this location. Sample results are shown in Table 21.
